# Safety Inspection Report

Annual Inspection

## Ilmington Playing Field

Site name: **Ilmington Playing Field**  
Date of inspection: **08 September 2025**  
Inspector: **Ben Wyatt**

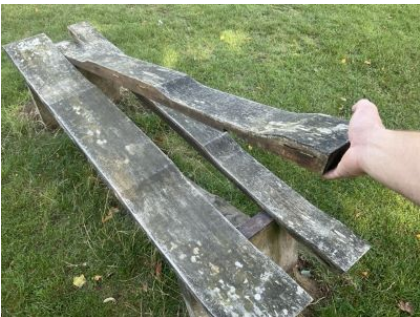
Moderate repairs are needed.

Repair.

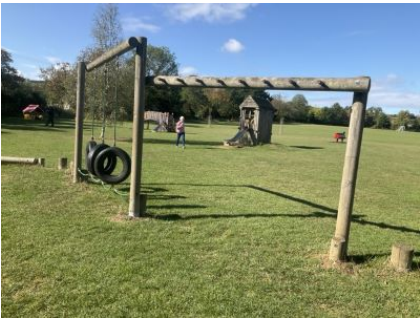
This equipment relies on one post for its stability. Special attention should be paid to maintenance (e.g. by monitoring degradation) and if necessary decommissioning the item before the end of its operating life. This is a requirement of the British Standard.

Strimmer guards are making it difficult to inspect for decay at surface level. The suspended tyres support with the overhead beam attached is slightly loose and should be closely monitored. Monitor all uprights for decay.

Consult with the manufacturer's guidance to determine suitable maintenance.

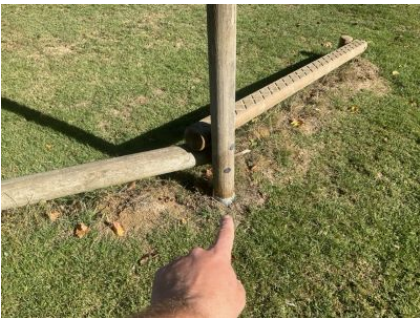
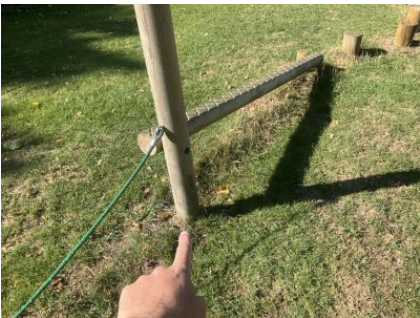
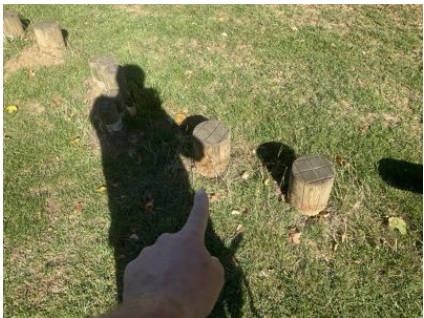
Loose in ground.

Monitor.

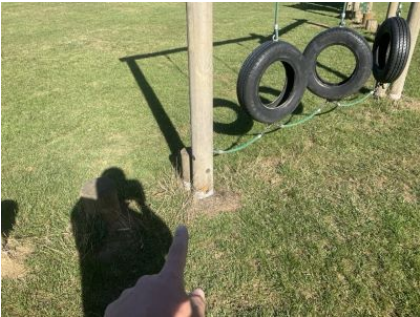
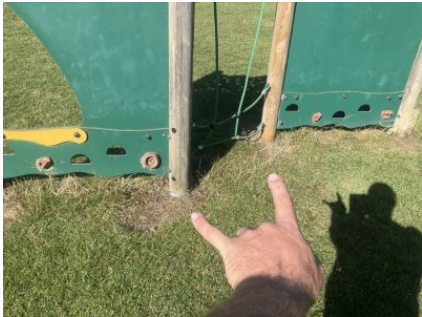
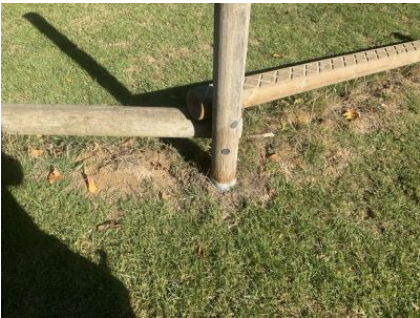
Timber is decayed.

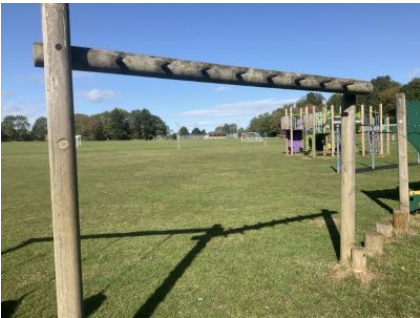
Overhead ladders and rings provide significant play value and benefits to children, and with it the risk of falling. Ensuring the surface remains in good condition will help to keep the correct balance between benefits and risk.

The protective surface under all bars and rings must be kept in good condition.

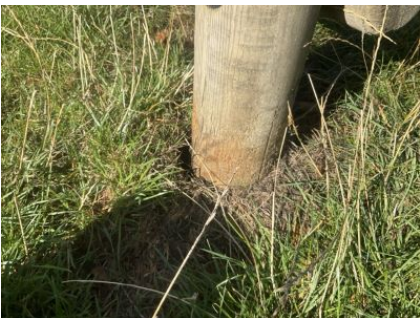
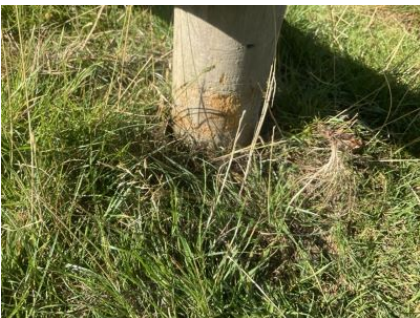
Strimmer damage is present on posts, allowing water to enter and timbers to soften. It can also remove the protective envelope around the timber. Prevent further damage and check timbers for decay throughout the year.

Prevent further damage.

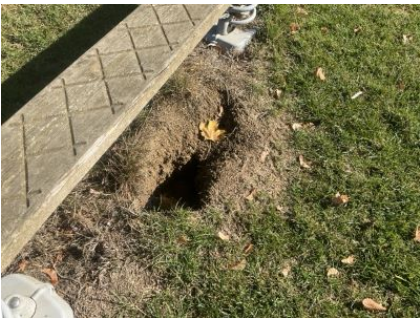
| Description | Tasks | Risk score |
|---|---|---|
| Surface has holes in it. | Repair. | 3 |

Repair.

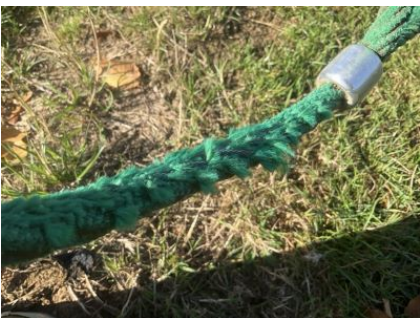
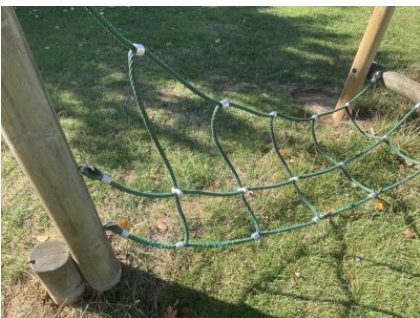
| Description | Tasks | Risk score |
|---|---|---|
| Exposed metal rope core(s). | No reasonably practicable action is identified. | 3 |

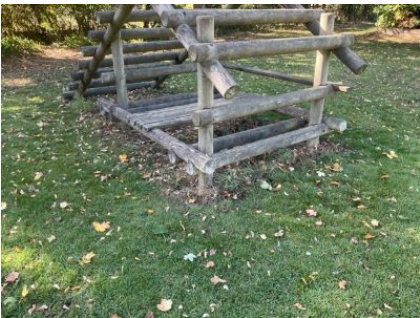
Surfacing Standard Compliance Findings  
1. A protective surface is required.

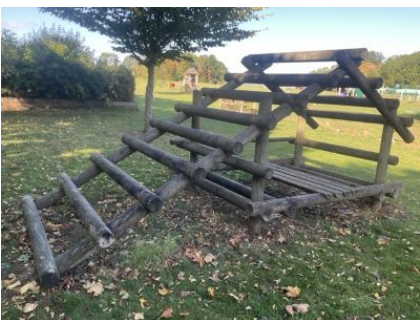
Timber is decayed.

Resonance testing indicates initial signs of internal decay.

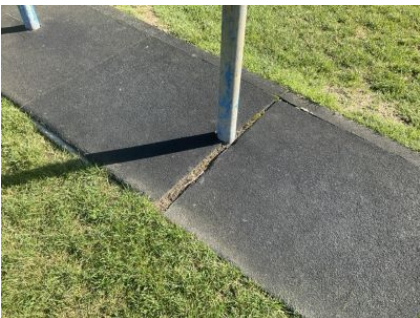
Gaps have opened up between tiles causing trip hazard.

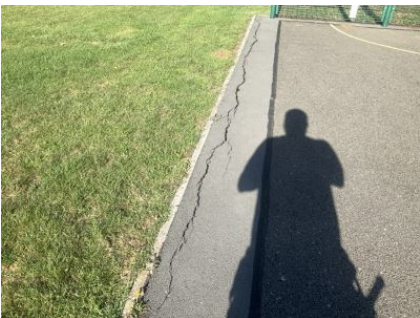
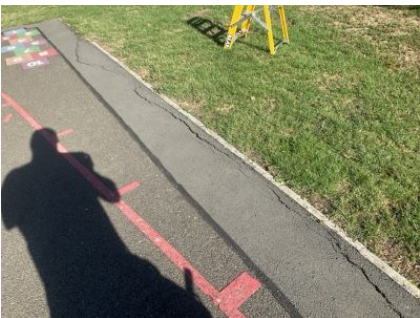
The surface is cracking.

Repair.

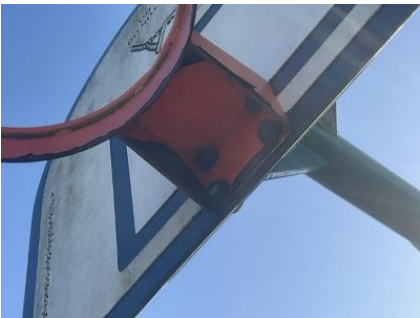
Cap missing.

Replace.

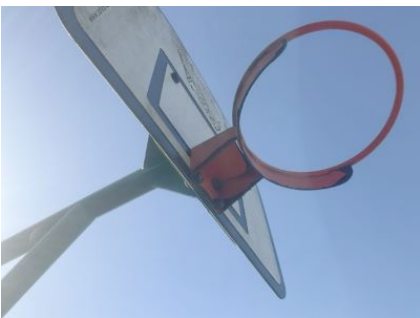
Paintwork is in poor condition.

De-scale back to good base material and coat with lead free paint, using appropriate precautions. Repairs may be necessary where corrosion is severe.

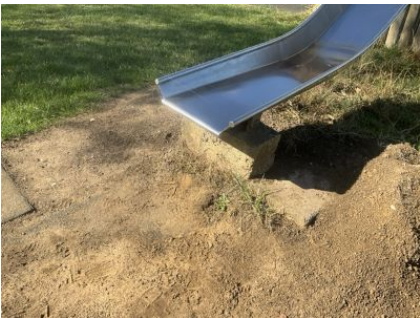
The foundations are exposed.

Cover the foundations to an appropriate depth.

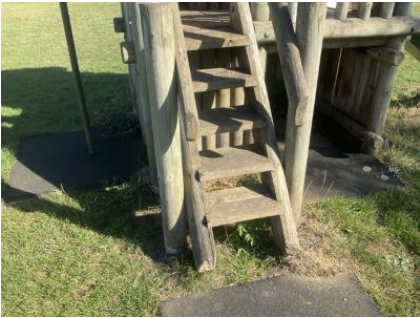
Access fails the entrapment requirements.

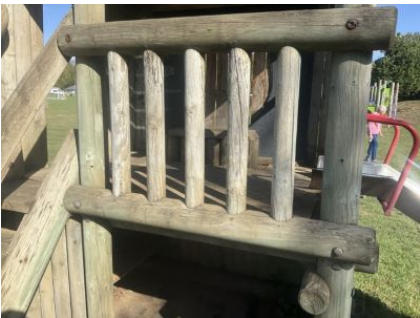
| Description | Tasks | Risk score |
|---|---|---|
| The spacing between the barrier bars is in excess of 89 mm. | No reasonably practicable action is identified. | 4 |

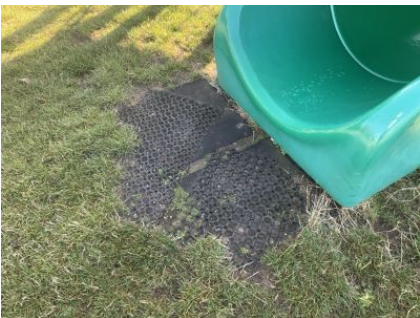
Surface is wearing.

Monitor for significant deterioration and rectify when necessary.

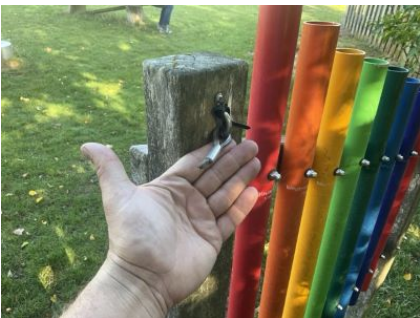
Item has some parts missing.

Replace the missing parts.

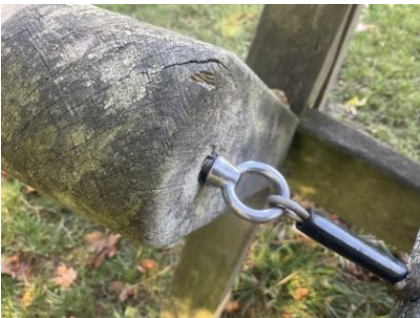
Bolt(s) loose.

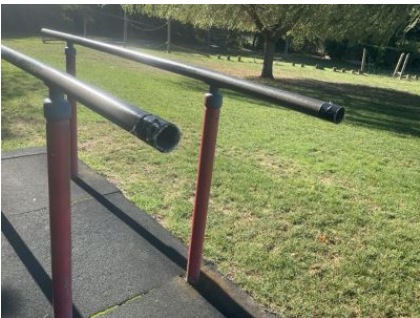
1. Surface needs repair.

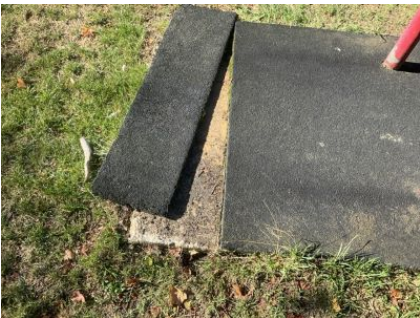
Surface needs repair.

Repair.

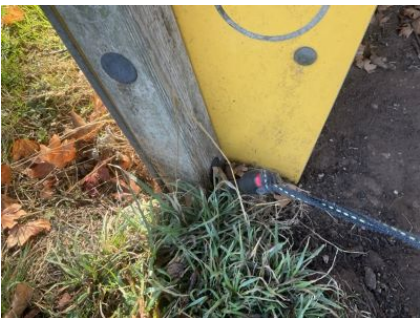
Timber is decayed.

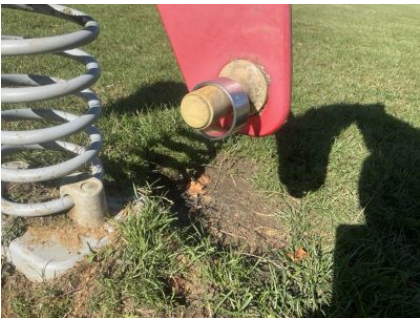
| Description | Tasks | Risk score |
|---|---|---|
| Protruding handles / foot rests. | No reasonably practicable action is identified. | <div></div> 3 |

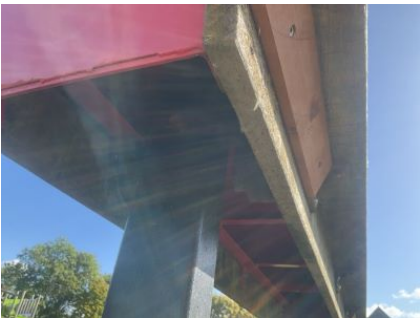
| Description | Tasks | Risk score |
|---|---|---|
| A crushing or shearing point is present between moving and/or stationary parts. | No reasonably practicable action is identified. | 4 |

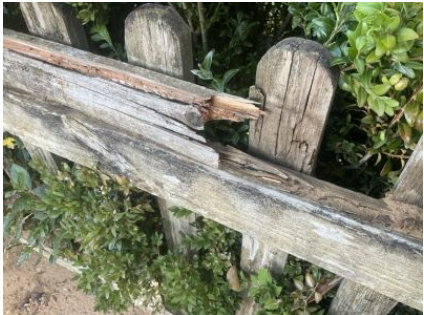
Timber is decayed.

Planters and fencing are decaying.  
Posts are becoming loose (gate post in particular).

Replace affected parts., Check on a routine basis.

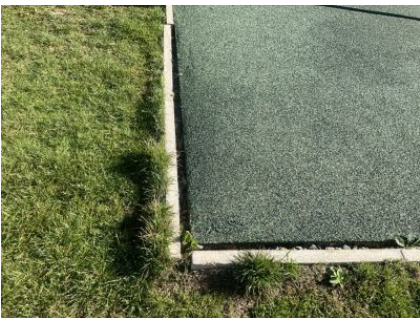
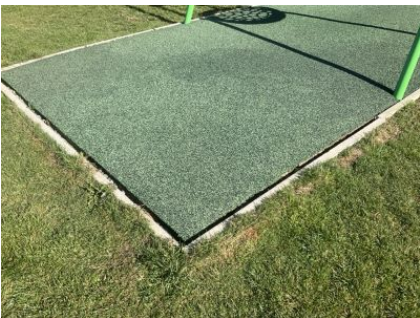
Shrinkage / separation of the surface. This may give a trip hazard.

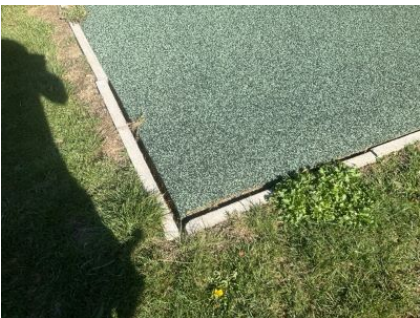
Shrinkage / separation of the surface. This may give a trip hazard.

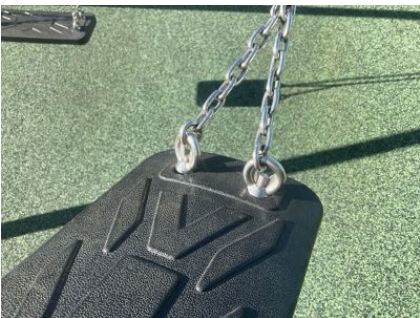
Swing seat bolt(s) loose.
