# Safety Inspection Report

Annual Inspection

## Ilmington Playing Field

Site name: **Ilmington Playing Field**  
Date of inspection: **08 September 2025**  
Inspector: **Ben Wyatt**

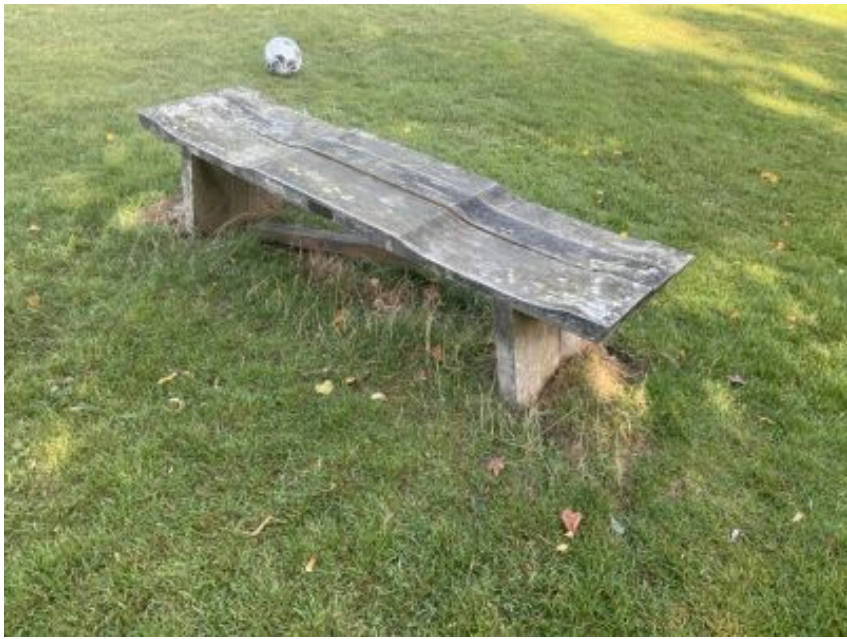
# Seating

Moderate repairs are needed.

Repair.

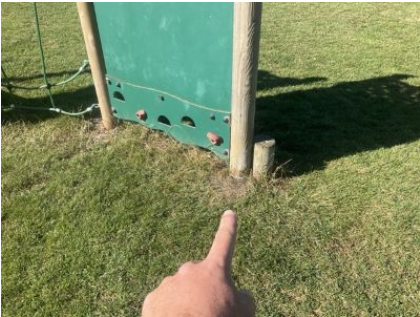
Loose in ground.

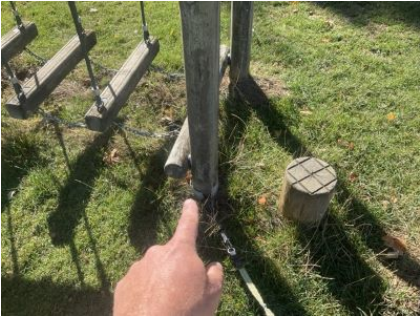
Timber is decayed.

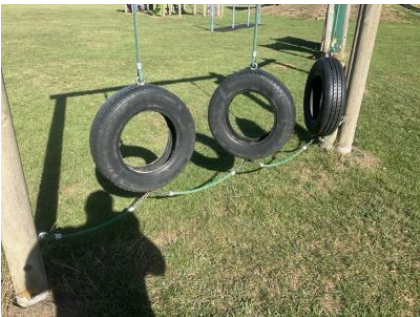
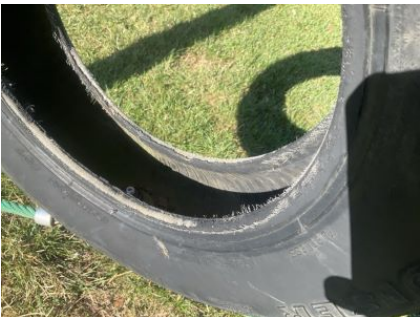
Additional comments are noted below.

Minor damage to tyres. Monitor for sharp metal strands.

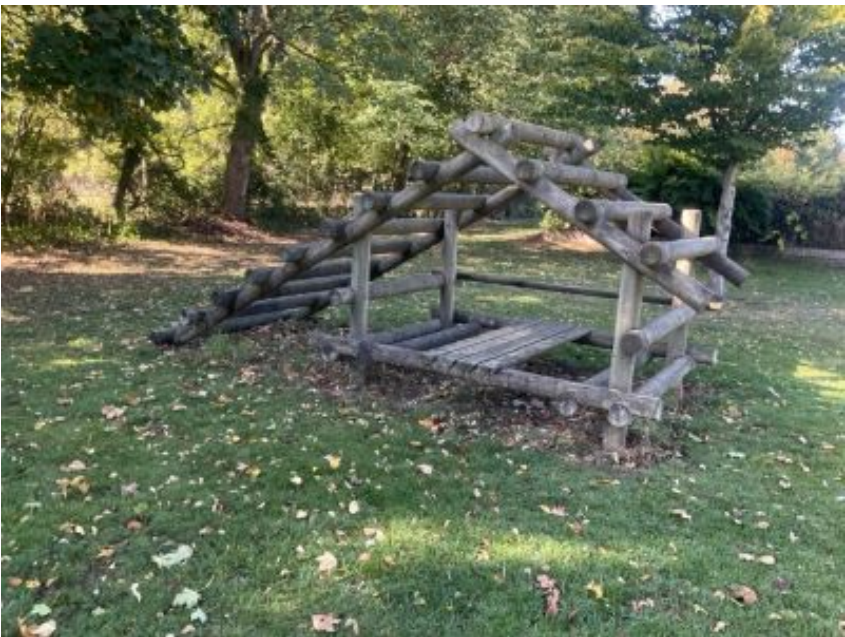
# Climber - Log Cabin

The item has the following maintenance findings:  
1. Timber is decayed.

Timber is decayed.

Resonance testing indicates initial signs of internal decay.

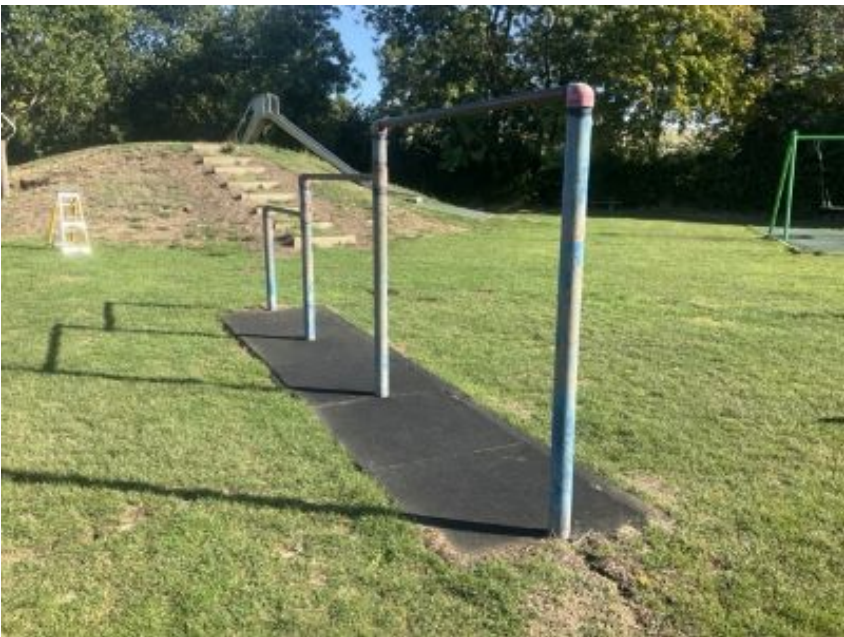
# High Bars - 3 Tier

Gaps have opened up between tiles causing trip hazard.

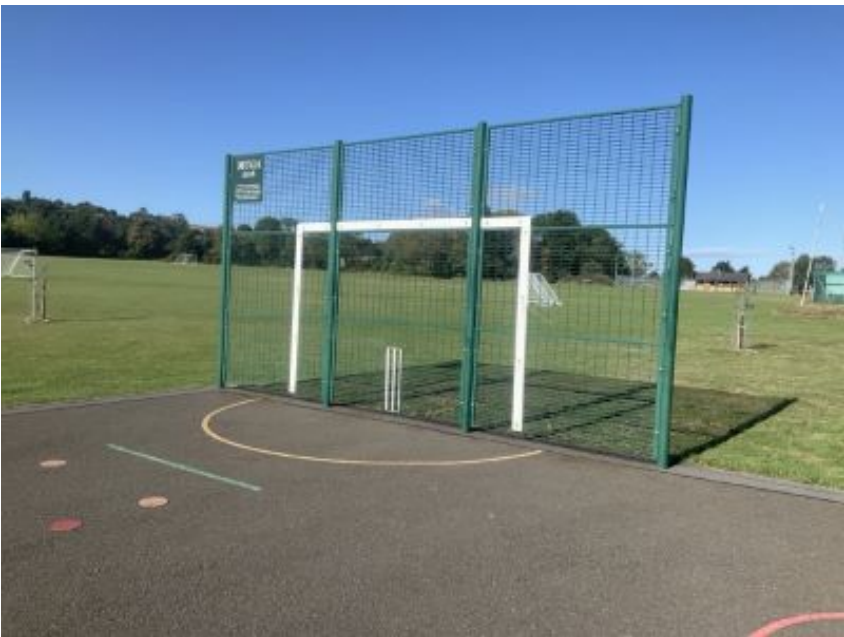
# MUGA - Basketball Post & Kick Wall

The surface is cracking.

Cap missing.

Paintwork is in poor condition.

Repair.

Replace.

De-scale back to good base material and coat with lead free paint, using appropriate precautions. Repairs may be necessary where corrosion is severe.

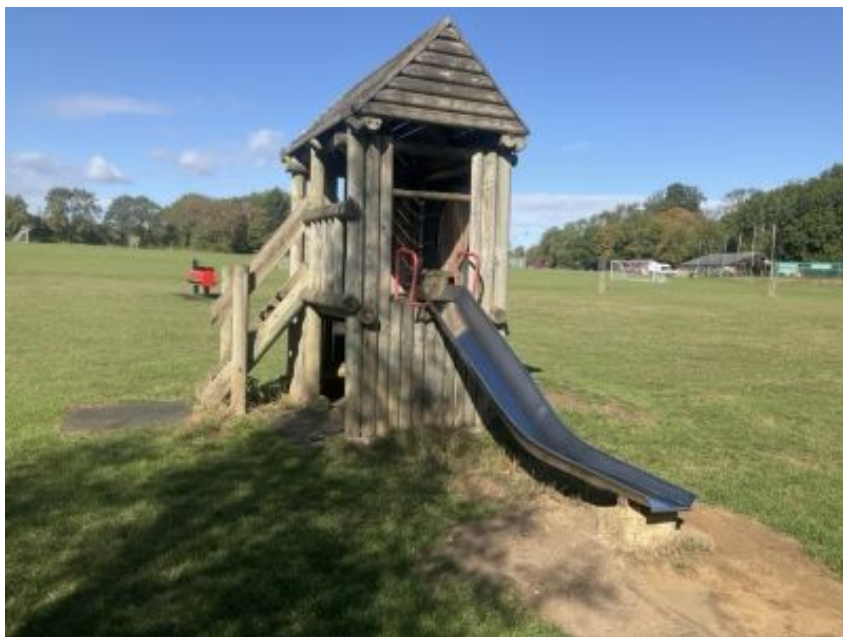
# Multiplay - Log Cabin & Slide

1. Access fails the entrapment requirements.
2. The spacing between the barrier bars is in excess of 89 mm.

The foundations are exposed.

Access fails the entrapment requirements.

Cover the foundations to an appropriate depth.

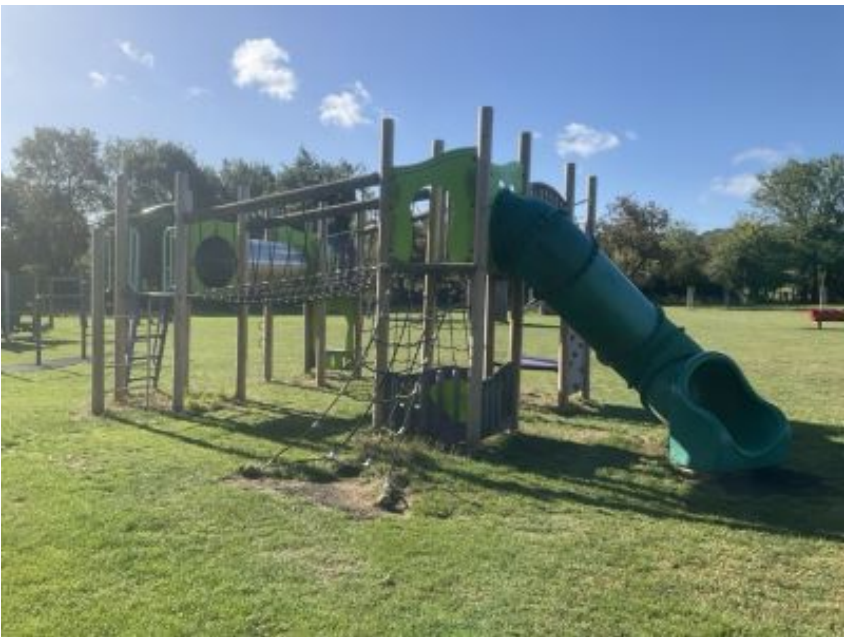
# Multiplay - With Tube Slide

Surface is wearing.

Monitor for significant deterioration and rectify when necessary.

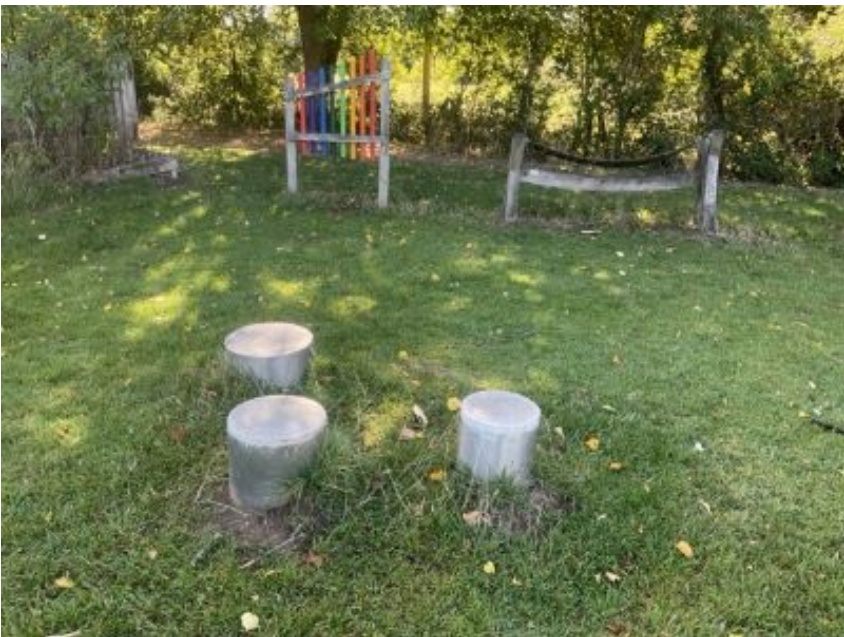
# Musical Activity Panels x 3

Item has some parts missing.

Bolt(s) loose.

Replace the missing parts.

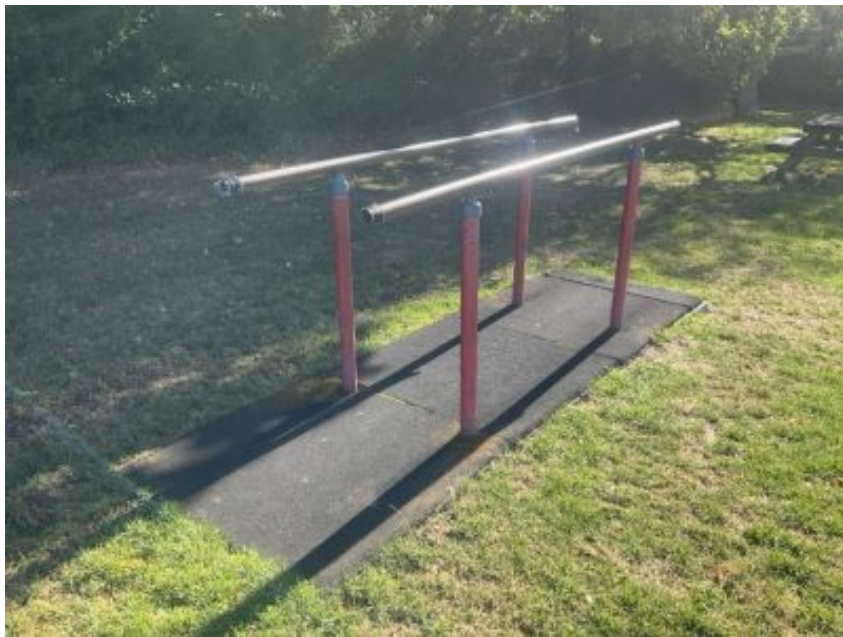
# Parallel Bars

Surface needs repair.

Repair.

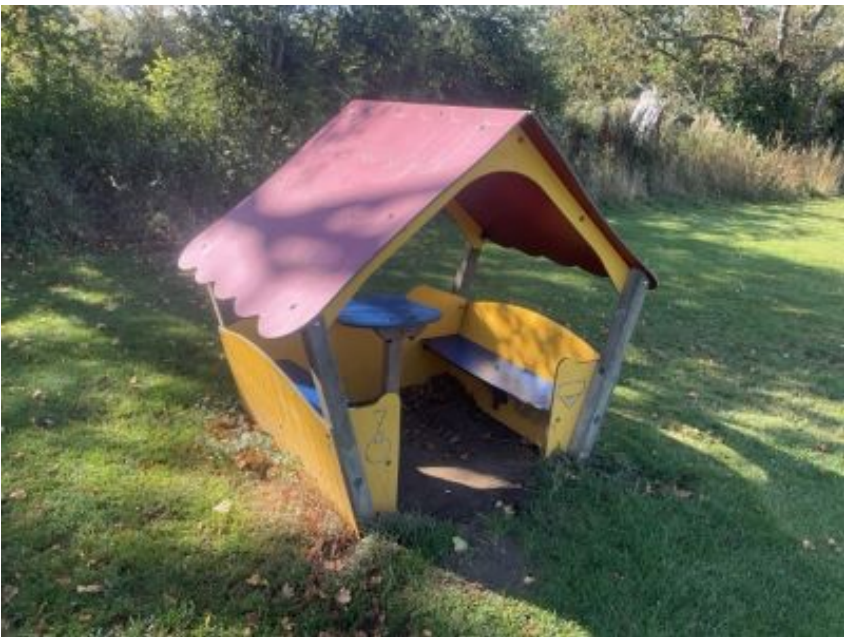
# Play House

Timber is decayed.

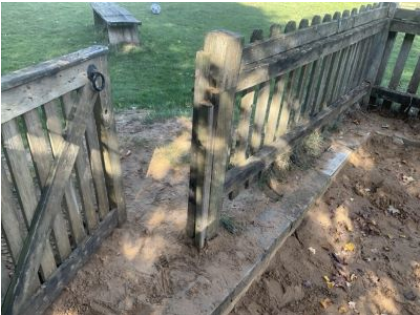
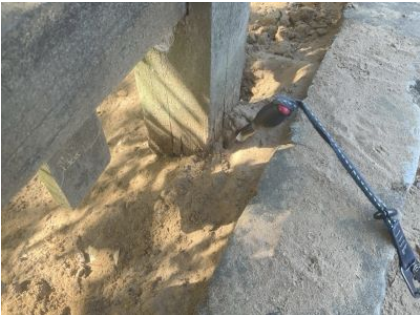
Timber is decayed.

Planters and fencing are decaying.  
Posts are becoming loose (gate post in particular).

Replace affected parts., Check on a routine basis.

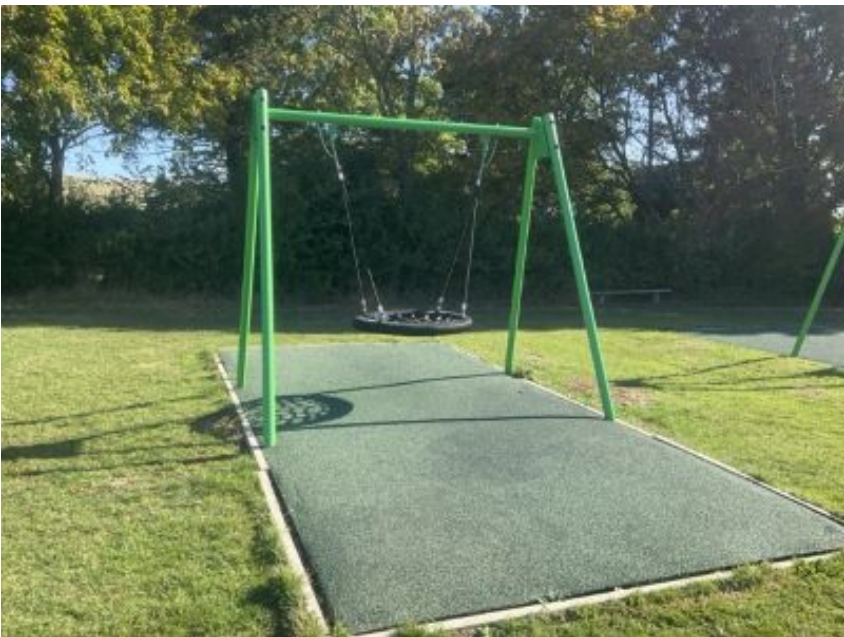
# Swing - Basket

Shrinkage / separation of the surface. This may give a trip hazard.

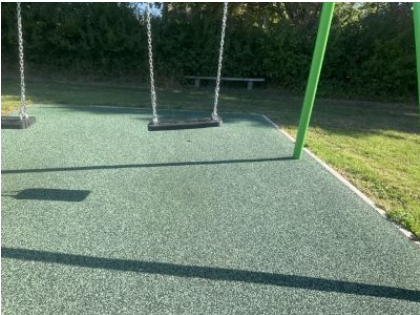
Shrinkage / separation of the surface. This may give a trip hazard.
